## Friede Completes Chula Vista Resort Fire Restoration

One of the more violent storms to hit central Wisconsin during the summer of 2017 resulted in one of the more distinctive projects of the year for Friede & Associates.

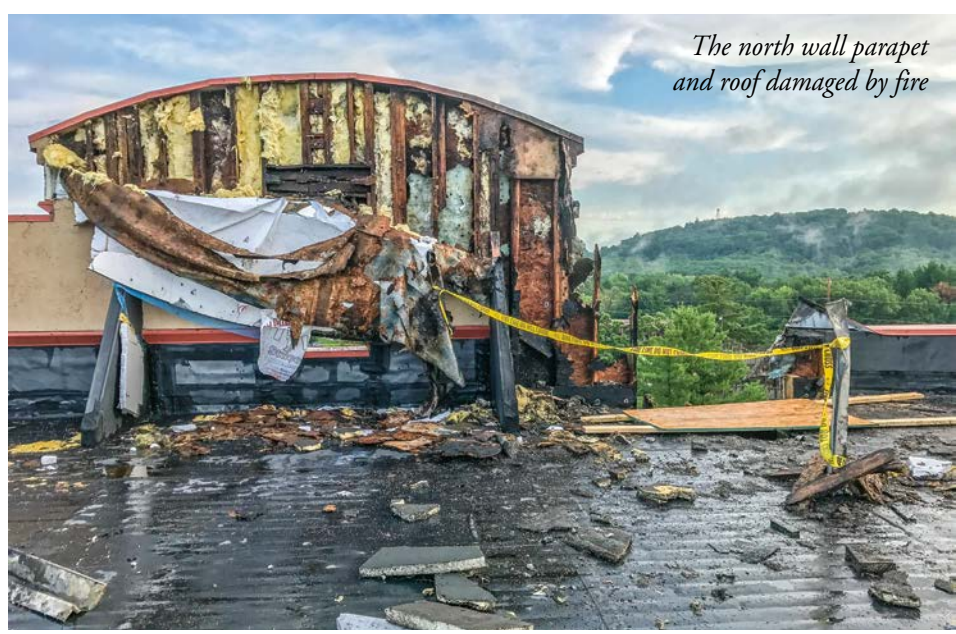
On the evening of July 19, 2017, witnesses reported that a strong thunderstorm had passed through the area, and waterpark guests reported being startled by a loud noise from the roof. An hour later, a guest at the resort noticed flames coming from the top of the building's parapet wall. Firefighters from the Kilbourn Fire Department arrived and quickly scaled the 60-foot walls. There they found one of the walls ablaze and noticed substantial damage to the adjoining roof area. They extinguished the fire and left.

A short while later, Chula Vista security personnel noticed flames coming from another section of the wall, nearly 100 feet away, and the fire department was called again. When they arrived, the firefighters found another parapet wall in flames and an additional section of the roof completely burned through.

*The north wall parapet and roof damaged by fire*

The plan for the wall replacement required that each day a section of the damaged wall would be removed, the opening size determined for the replacement panel and a new section of wall rebuilt on the ground. Then, the panel would be lifted by crane back into place, where it would be secured to the glulam super structure of the building.

Once the new panels were in place, a new vapor barrier was installed on the inside of the panel and then the wall cavity was insulated. The interior side of the panel was then drywalled and painted. Finally, the exterior was sheeted and then a vapor barrier was installed prior to the EIFS system being reinstalled.

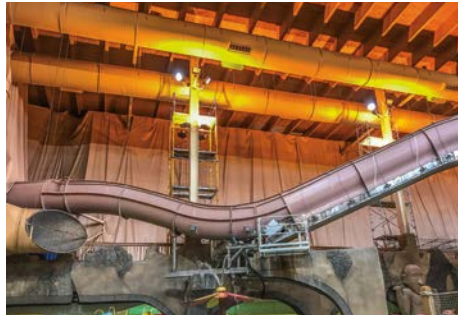
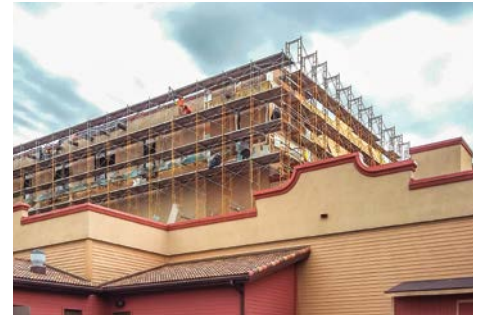
*Left: A fabric cover over the interior scaffolding helped reduce the heat loss from within the waterpark. Exterior scaffolding was essential to replace the parapets and roof structure.*

We coordinated with Chula personnel and senior management to devise a plan for the removal and reinstallation of nearly 200 feet of wall sections while keeping the waterpark open. This would ultimately include the installation of both scaffolding on the inside and outside of the exterior walls and a fabric cover over the scaffolding to reduce the amount of heat loss from the

waterpark, and to keep the environment outside from impacting park guests.

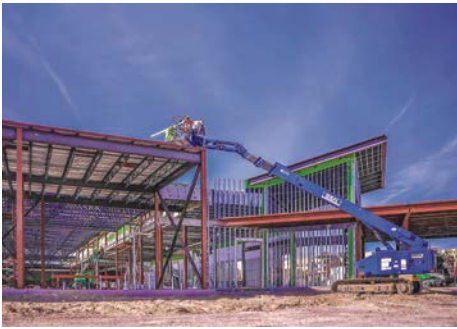
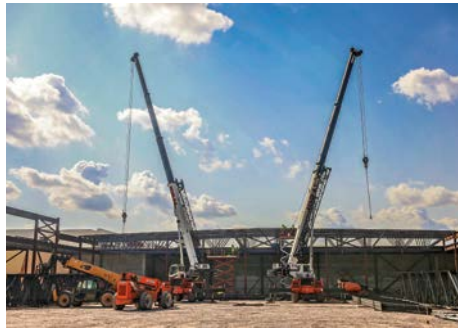
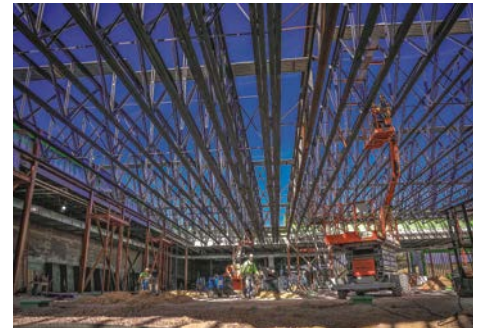
# Kalahari Resorts & Conference Center Update

The Friede team recently completed the site work and has begun the next stage in a multi-phase plan to more than double the footprint of Kalahari Resorts & Conventions Conference Center in The Wisconsin Dells. The existing conference facility will be expanded to more than 200,000 square feet to make room for additional meeting and banquet spaces. With the site work complete, the actual building construction began with the erection of structural steel in September.
